**SUMMARY OF INCIDENT:** Based on interviews, review of data collected by other investigative agencies, and site visits at Salisbury Millworks.

On March 7, 2008 Salisbury Fire Department Stations 1, 2, 3 and 4 consisting of 4 Quints, 1 Rescue Engine, 1 Squad, 1 Battalion, 1 Safety Officer and 1 Division Chief responded to a reported structure fire at Salisbury Millwork. Twenty members of the Salisbury Fire Department were initially dispatched as a first alarm assignment.

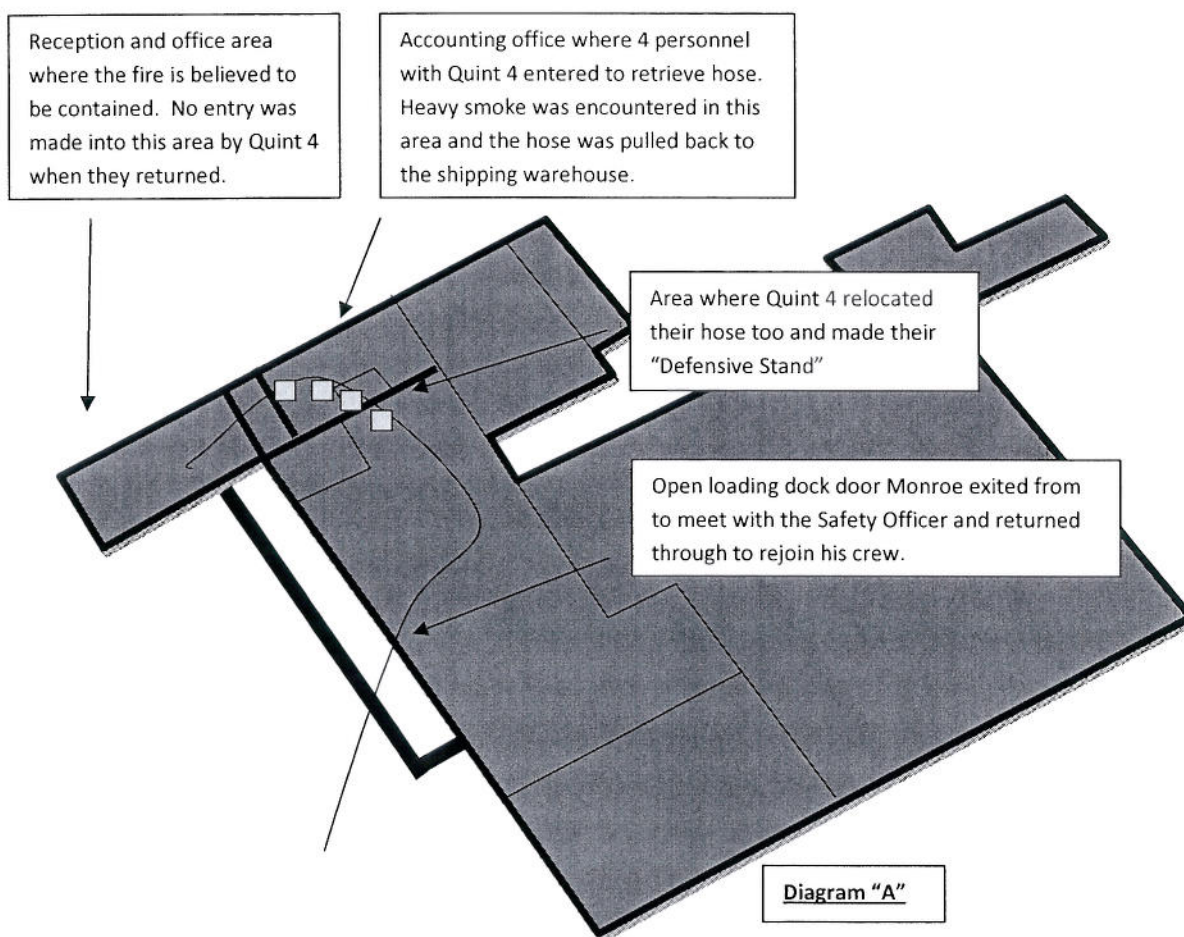
The Operations Officer spoke with Quint 4 Captain and provided him with the updated plan focusing on protecting the shipping area (see diagram "A").

The line for Quint 4 originally went into the reception & office area through three different firewalls, however when Quint 4 crew re-entered to protect the firewall separating the reception & office area from the accounting office, they encountered heavy smoke in the accounting office. The Captain determined this area was not a safe place for his crew so they relocated the hose to the shipping warehouse by pulling it back to the firewall separating the shipping warehouse and accounting office.

Quint 4 entered into the shipping area where they originally left the 2 ½ line they were operating in the office. As they proceed into the shipping area, the Captain of Quint 4 stated that visibility was still good, moderate to heavy smoke above his head (six feet from the floor) with no heat. As his crew continued to follow the hose and walked standing upright through the shipping area, visibility remained good and they encountered no heat. The crew from Quint 4 entered into the accounting office area and began to encounter heavy smoke (three feet from the floor) and some heat. The Captain informed his crew they would back their line out of the accounting office area to a safer location near the firewall separating the shipping area from the accounting office.

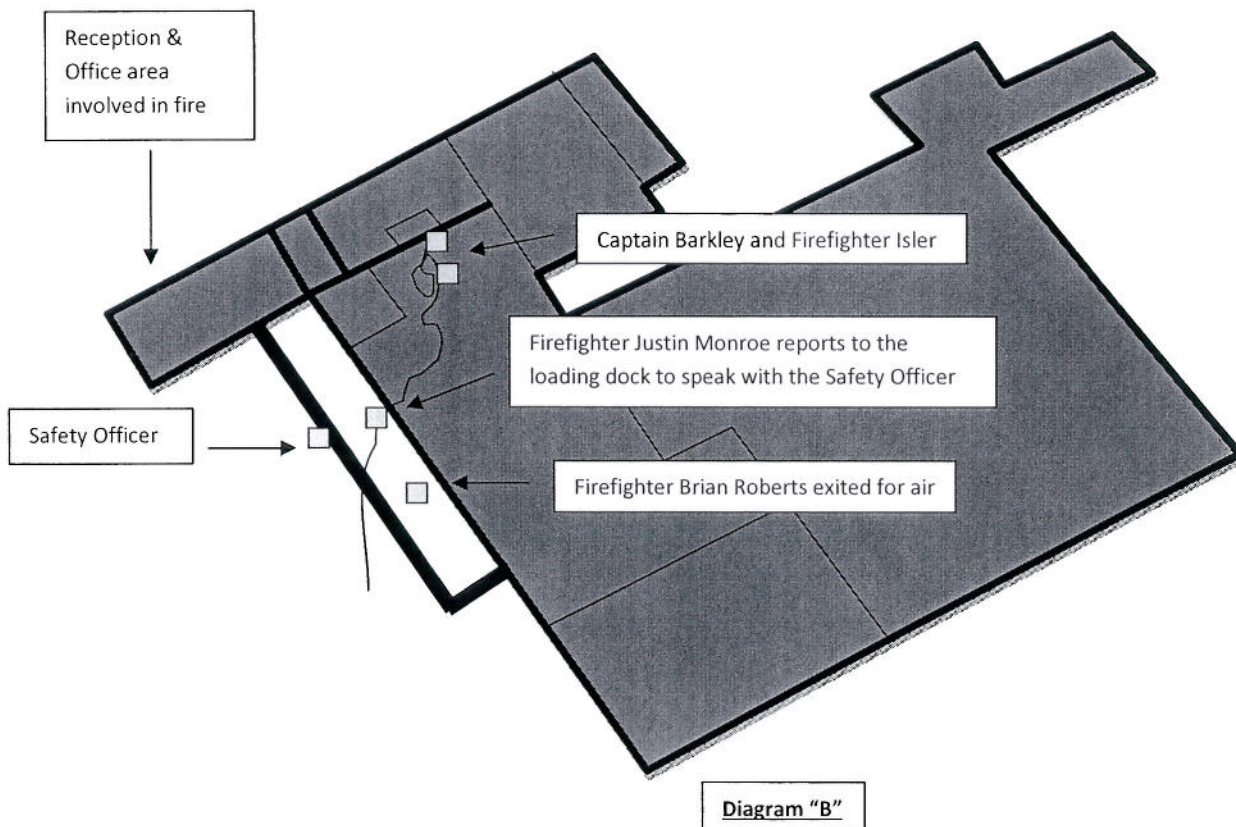
The Captain from Quint 4 attempted to contact outside crews and ask for help pulling his line back, but is unable to make contact via his portable radio. He can receive transmissions from outside however he cannot transmit out. His crew is now about sixty feet from their point of entry and closer to other points of egress. The Captain states that visibility is unchanged (good) and the door his crew entered is visible. The Captain from Quint 4 can hear transmissions from Safety 1 and Operations that a RIT Team is being sent in for his crew. The Captain of Quint 4 advises Squad 1 driver Monroe to go back to the door and tell outside crews they are in a safe location and everything is fine. Quint 4's rider also exited for air possibly unknown to the Captain, as crews were pulling the hose back (see diagram "B").

Monroe returns to the open loading dock door where the hose exits and meets with the "Safety Officer" on the loading dock. He confirms his crew (Quint 4) is in a safe location and everything is fine, he then re-enters to return to his crew. Safety 1 relays this information back to Operations and the RIT Team stands down. Safety 1 does not recall the level of smoke in the shipping area however, he does recall seeing Monroe come out of the open doorway standing-up and re-enter standing.

Quint 4 Captain noticed a roll in the hose blocking a hall/doorway he and Isler were using as a prop. The Captain asked Isler to pull the line back to clear the doorway. As Isler is backing the hose out, he noticed the fire is behind him and his Captain. He informed his Captain, who then pulled the nozzle back to Isler when the hoseline suddenly loses pressure. Conditions worsen at this point and Quint 4 Captain laid the nozzle on the floor and crawled about five feet to Isler. They were just past the doorway in the warehouse leading from the accounting office area. Quint 4 Captain tells Isler to wait until he reaches him before proceeding. With deteriorating conditions, they join and proceed to follow the hose, but went the wrong way returning back to the nozzle. After a few seconds of discussion on which way was correct, with the Captain leading, they began to follow the hose-line toward the door. The Captain of Quint 4 confirmed they were going the correct way as he saw a fire extinguisher on his right side which he had seen when first entering the building. While crawling back the Captain of Quint 4 encountered a spaghetti pile of hose, which is attributed to when his crew was trying to pull the line back. Due to conditions deteriorating and changing rapidly Quint 4 Captain is not able to see Monroe as (Monroe) is proceeding back to the company. As the conditions suddenly changed outside crews reported the building became fully engulfed with fire from one end to the other in just seconds. May-Days were issued by Quint 4 Captain as he worked his way through the spaghetti'd hoseline. The Captain turned to converse with Isler however Isler is not there. Quint 4 Captain called out for Isler and went back several feet to look for him when the Captain is overcome by the heat. At this point, the Captain turns back around to try to make it out following the line and reaches a cut in the hose-line. Due to physical exhaustion, the captain laid on top of the hose where the water was leaking to cool off. The Captain makes several May-Day calls and knows one went through because heard the RIT Team being deployed. He then sounds his PASS device so the RIT Team can find him.
